## GETRAG 265/5 REBUILD

Article by: **Dave @NZ**

Article applies to: all BMW models with the Getrag 265/5 transmission.

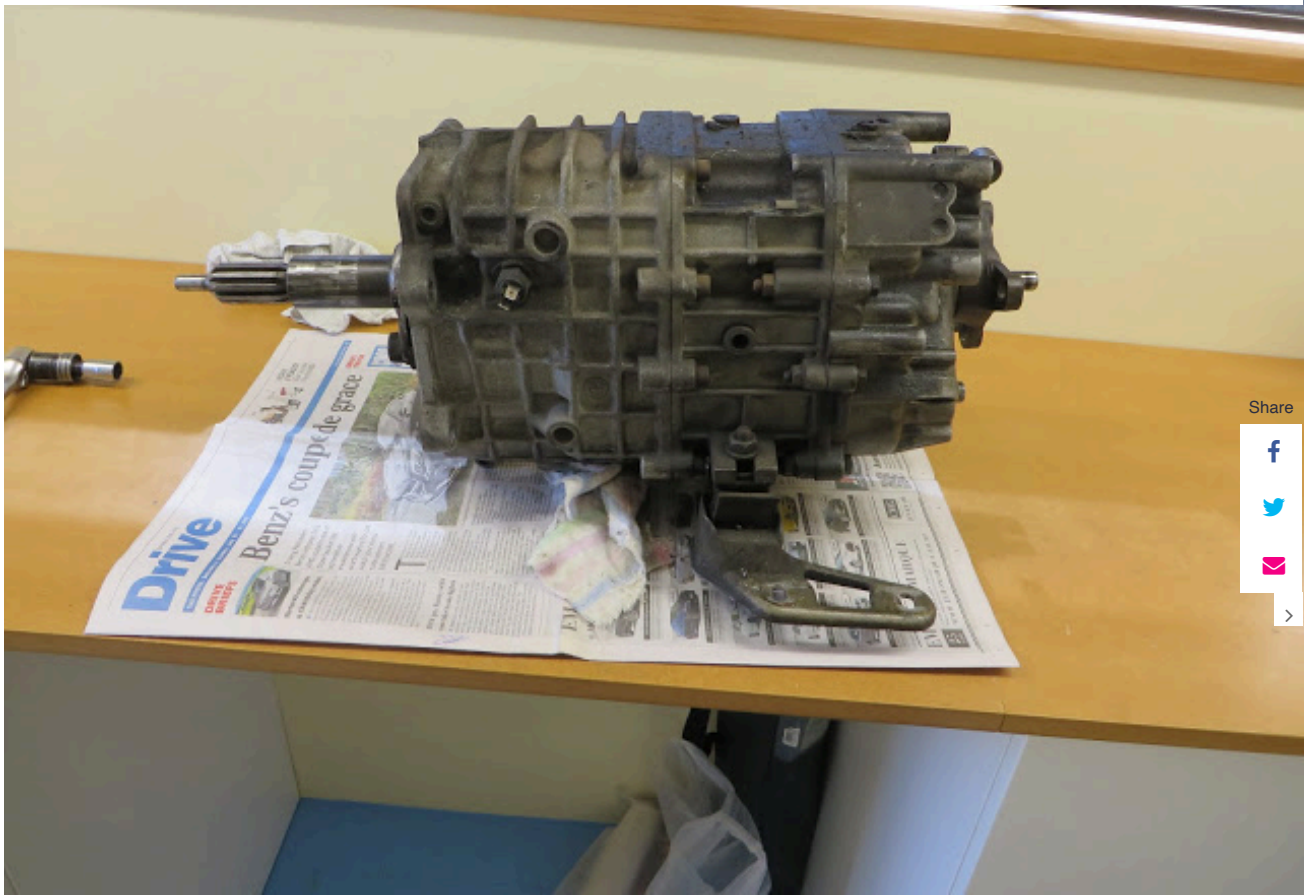
The front came off good and exposed the bearings which looked all intact only thing no good was one of the input shaft shims looked like it had taken a pounding and was all cracked.

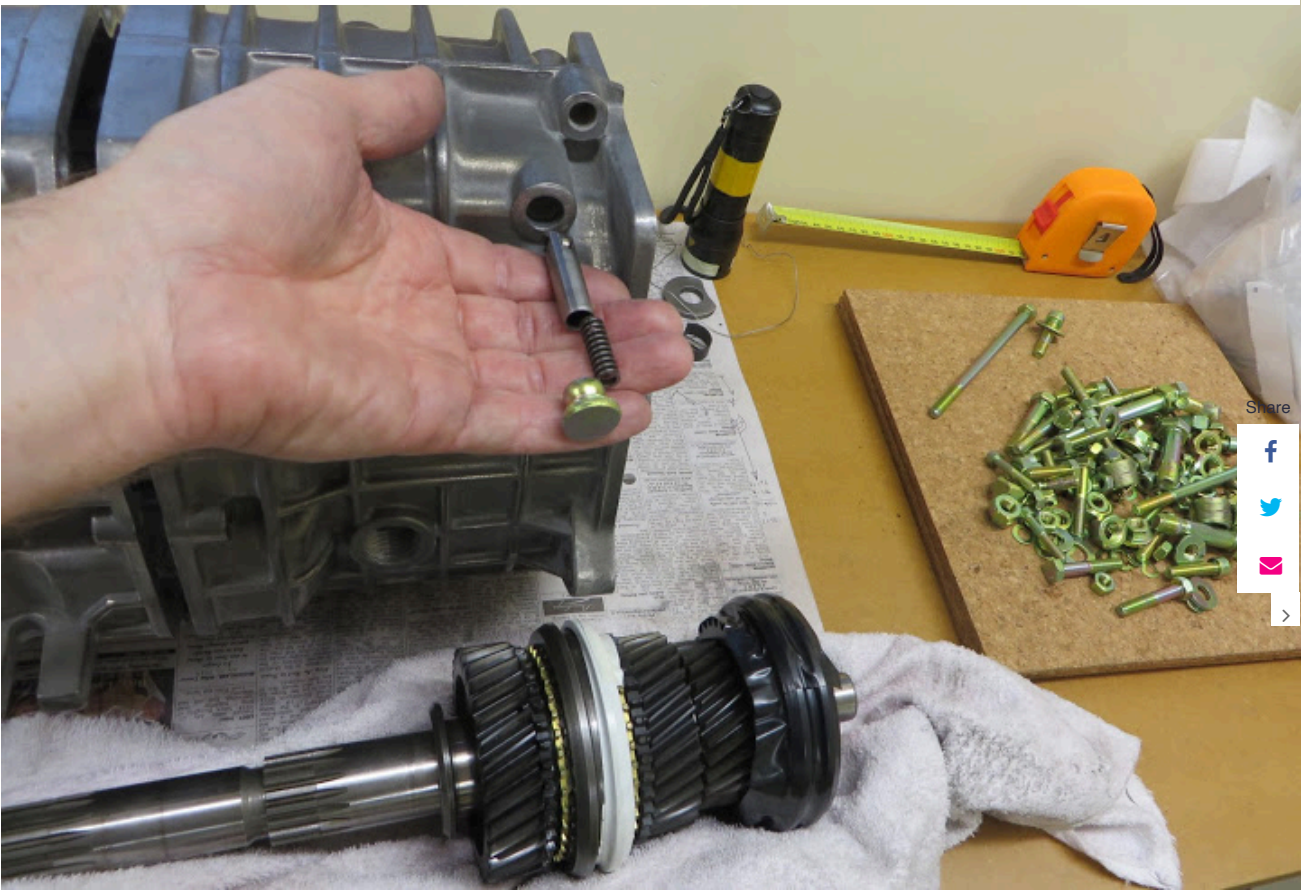
Next up is the front housing just had to remove the main selector shaft detent spring and plunger first it is a hammer in pry it out with screwdrivers type of thing.

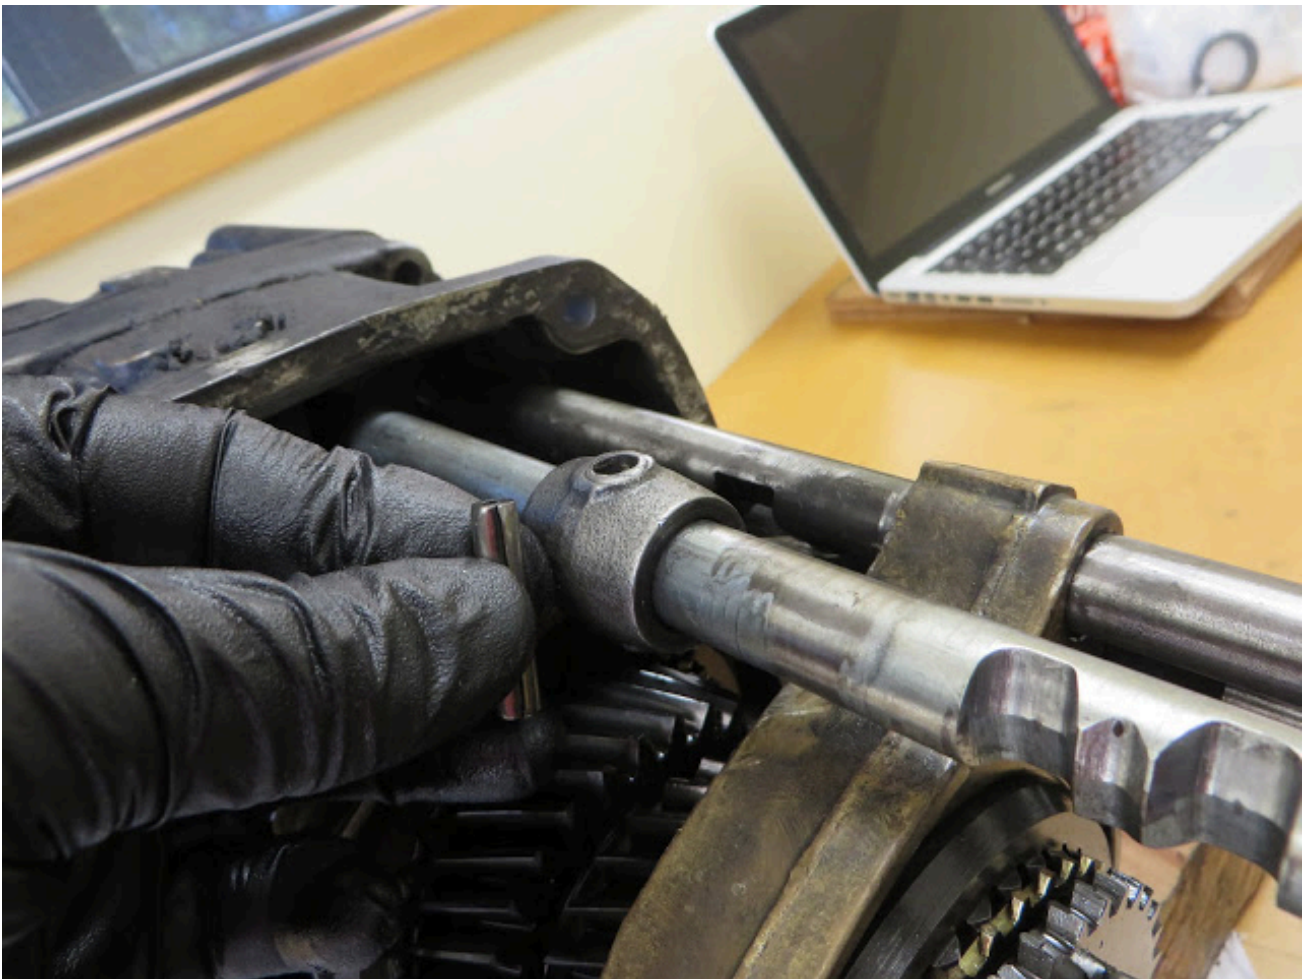
Had to remove the roll pins, 2nd 3rd hub roll pin is tricky to remove it basically hammers down the gap between the gear teeth.

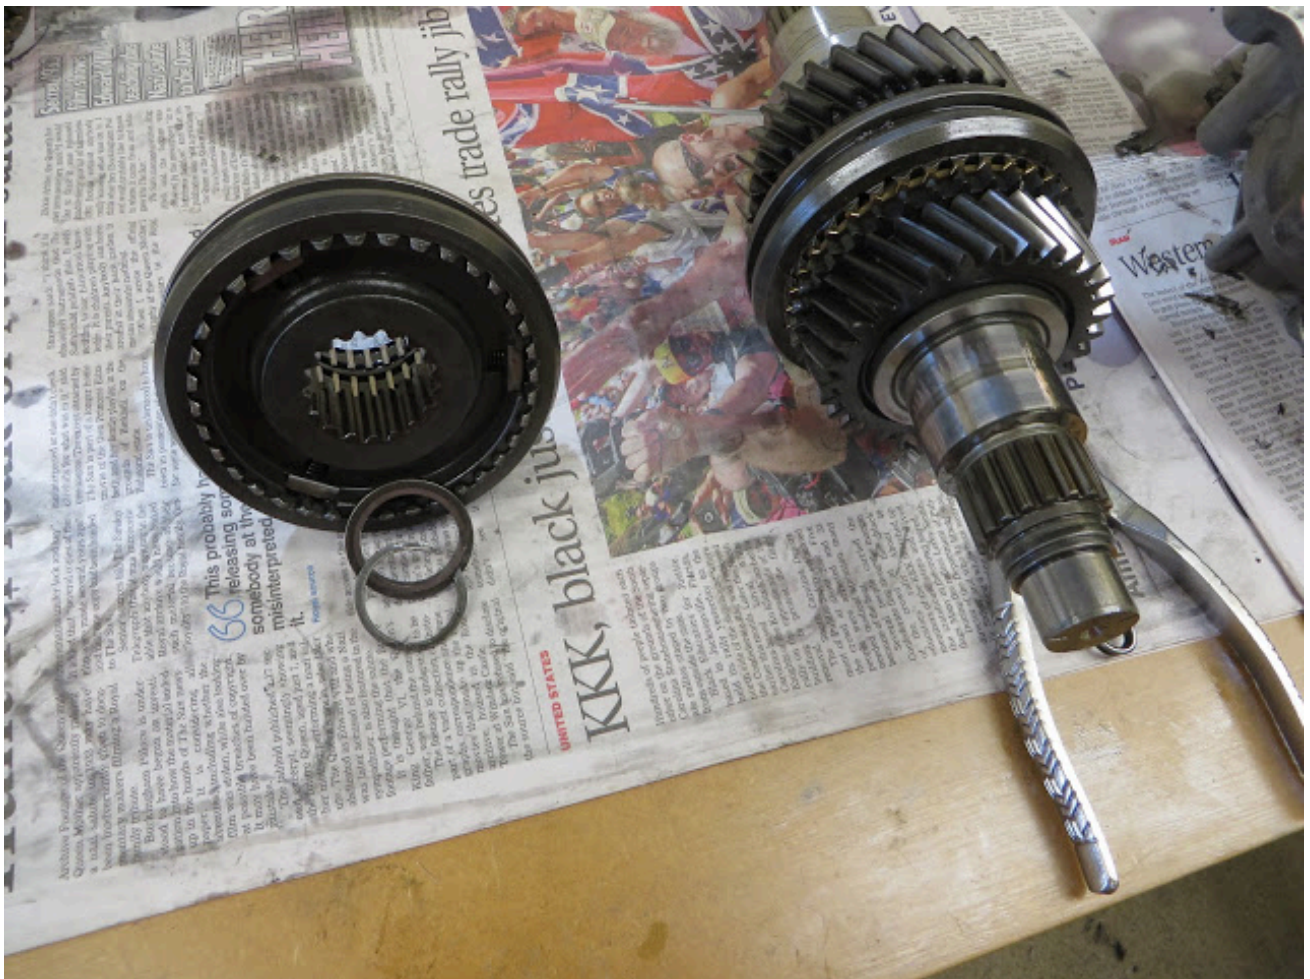
4-5 sync hub removed.

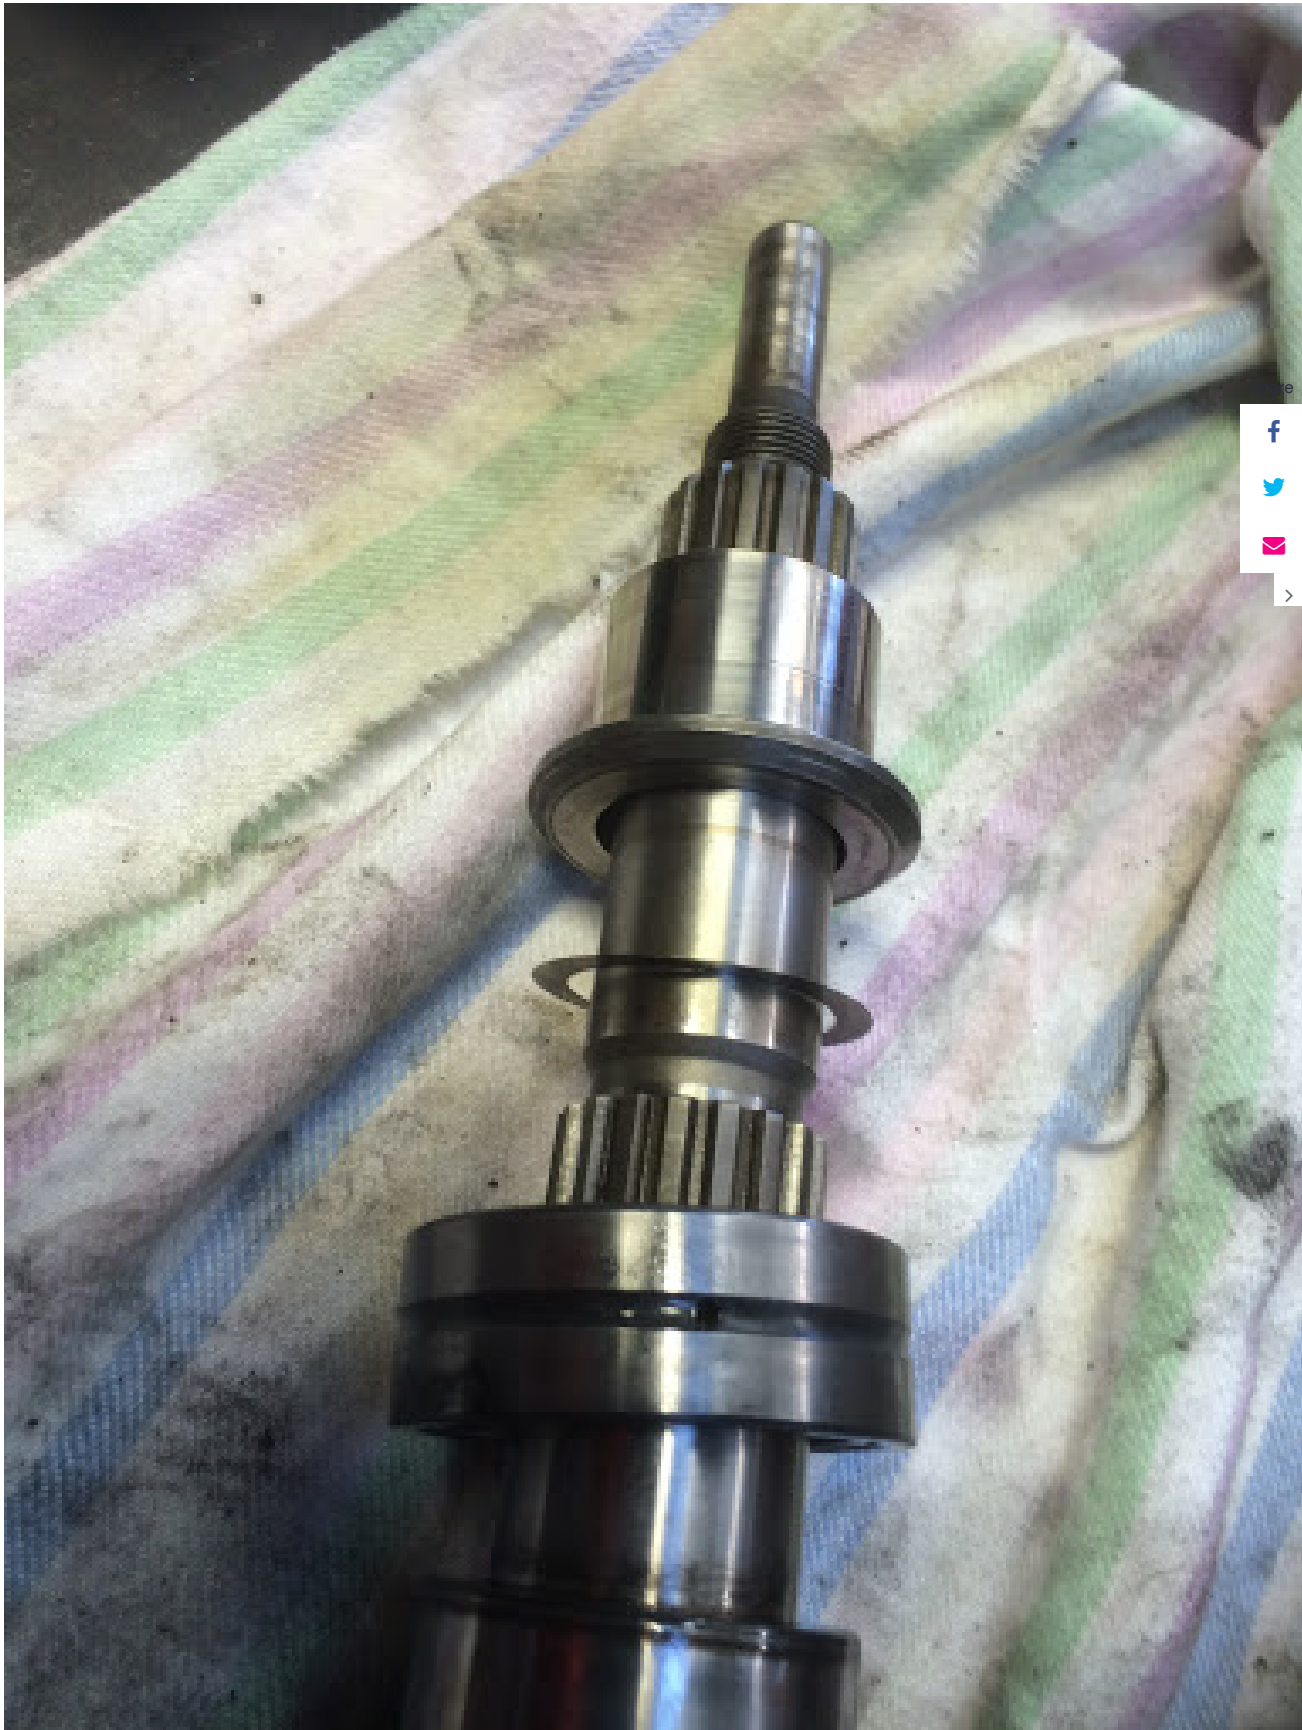
To get the 1st gear inner sleeve off the shaft good "C" plates which clamp around the flange then good heat up with the hot air gun and press it off.

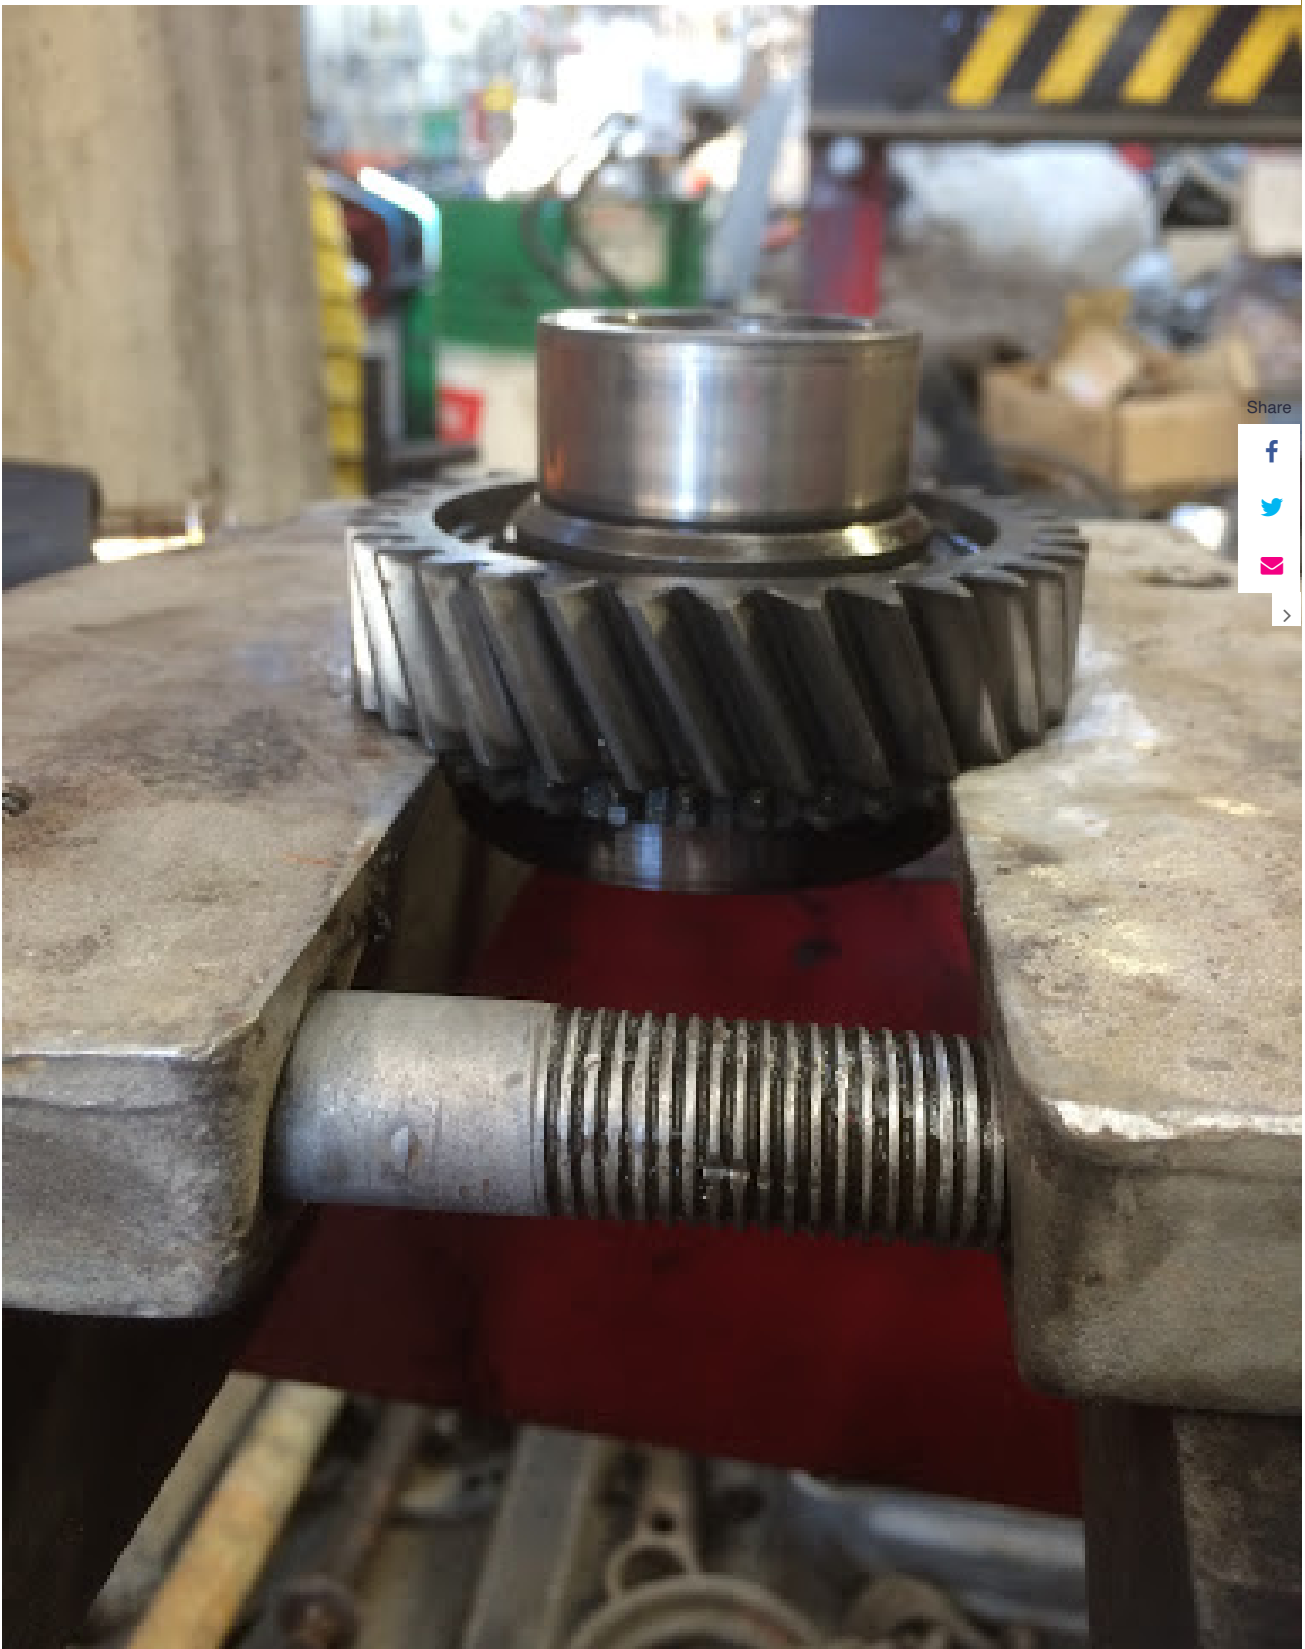
Next up was press the 2nd gear and inner roller race off, same procedure but the weight is taken by the sides of the teeth. 4.5 tons to get it moving and was really glad no teeth broken. Had a few goes at it just hoping the teeth did not break off.

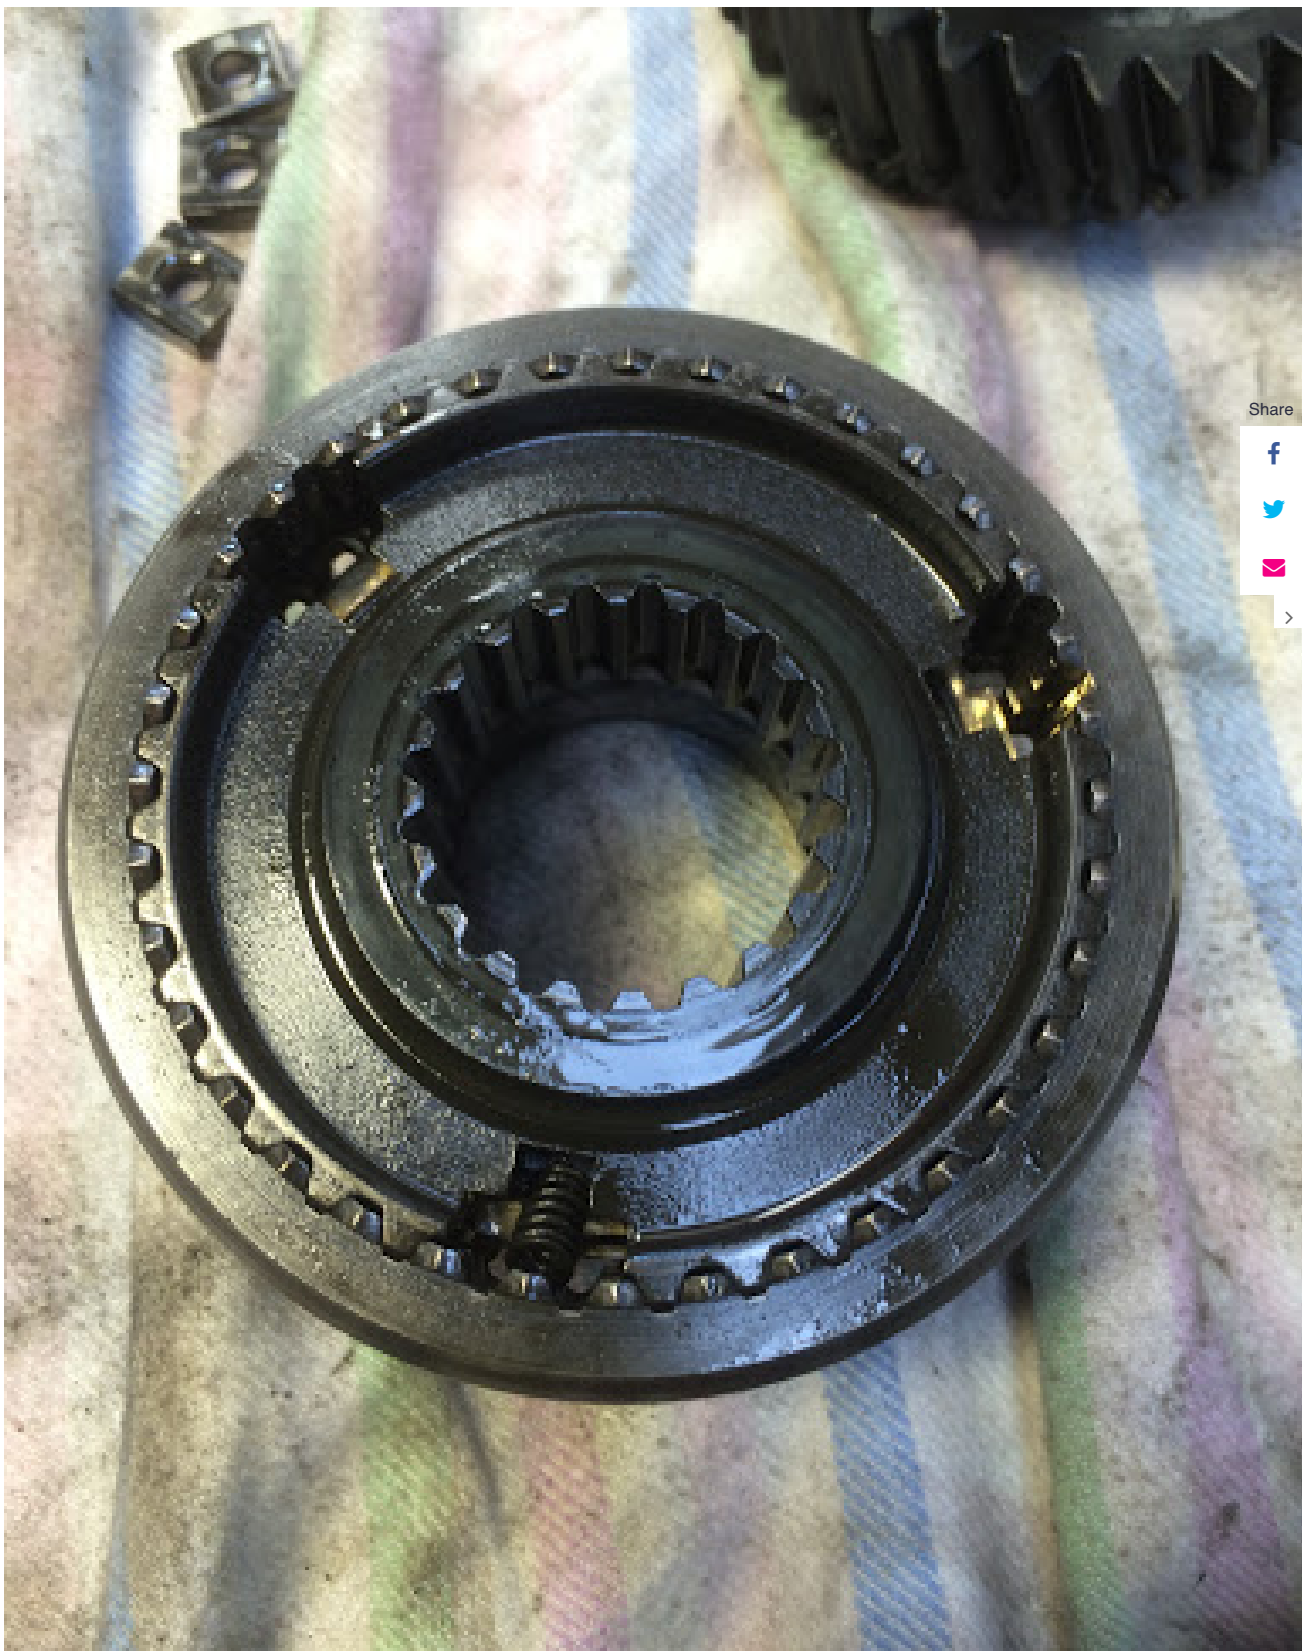
Everything inside the box is covered in black grime and took lots of work to clean it all off.

Everywhere I looked there was black grime even though oil seemed cleanish.

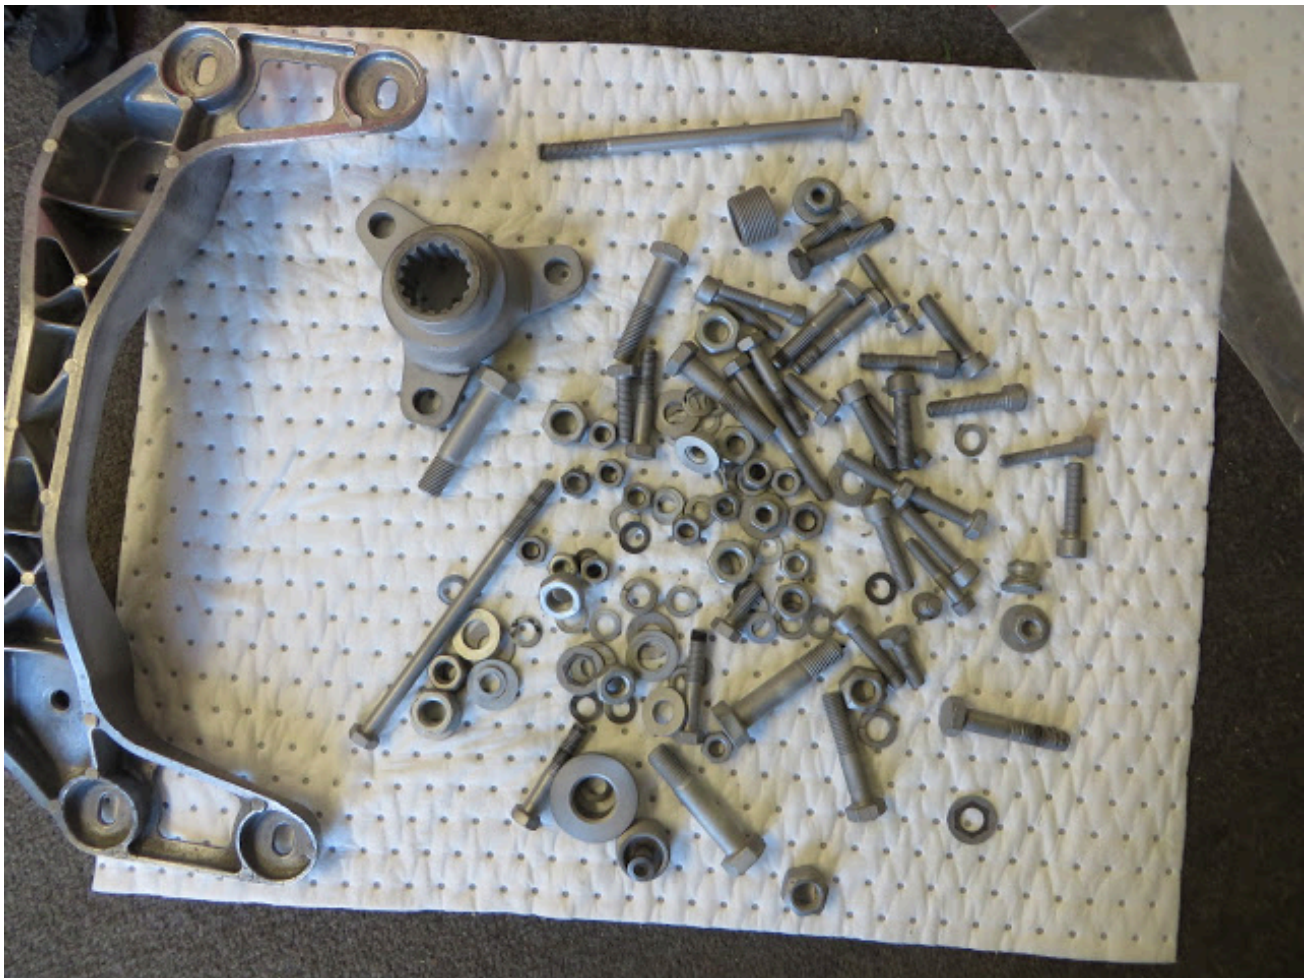
I bead blasted the hardware parts (cross member not included) and then they were gold Zinc coated, shown in one of the above photos.

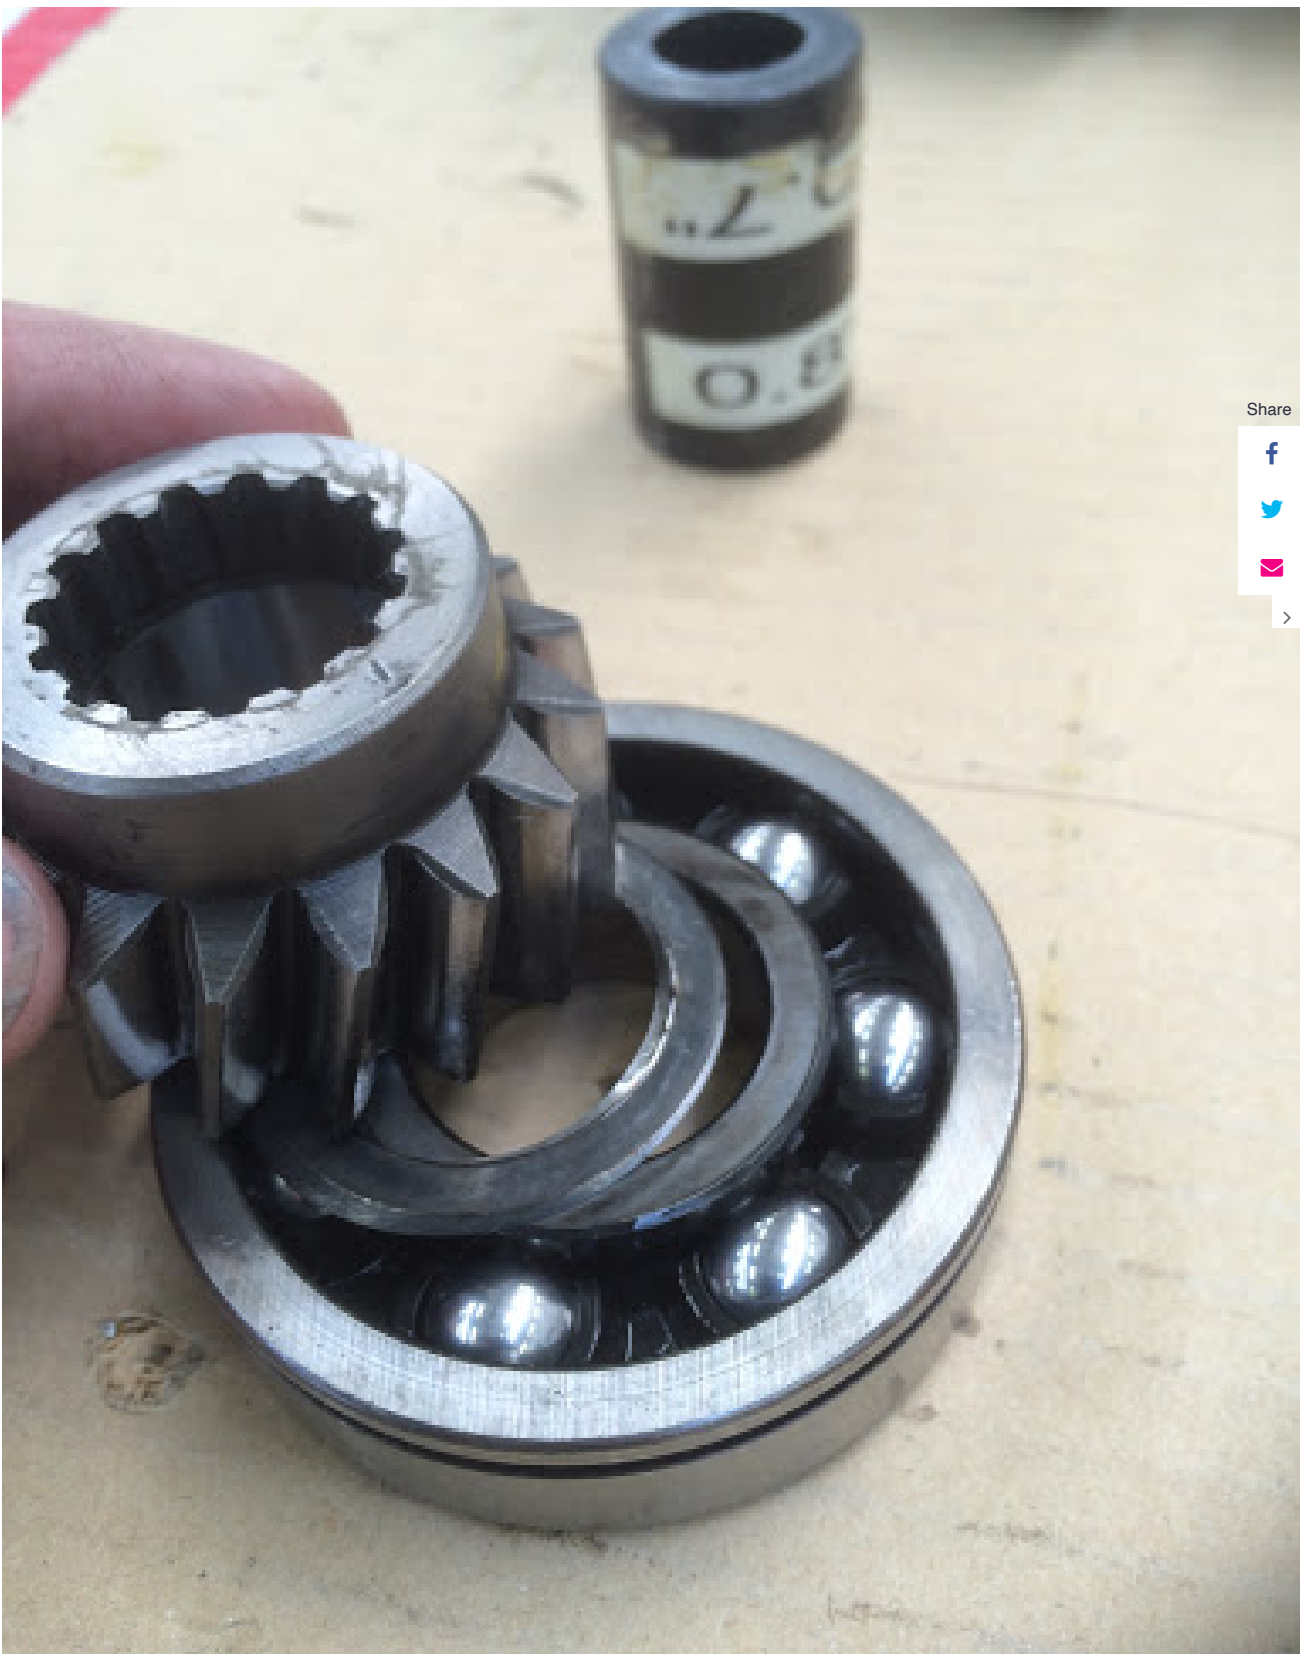
Shimming for reverse was dodgy with too thin a shim in there, what I used was a shim from a classic Mini suspension ball joint.

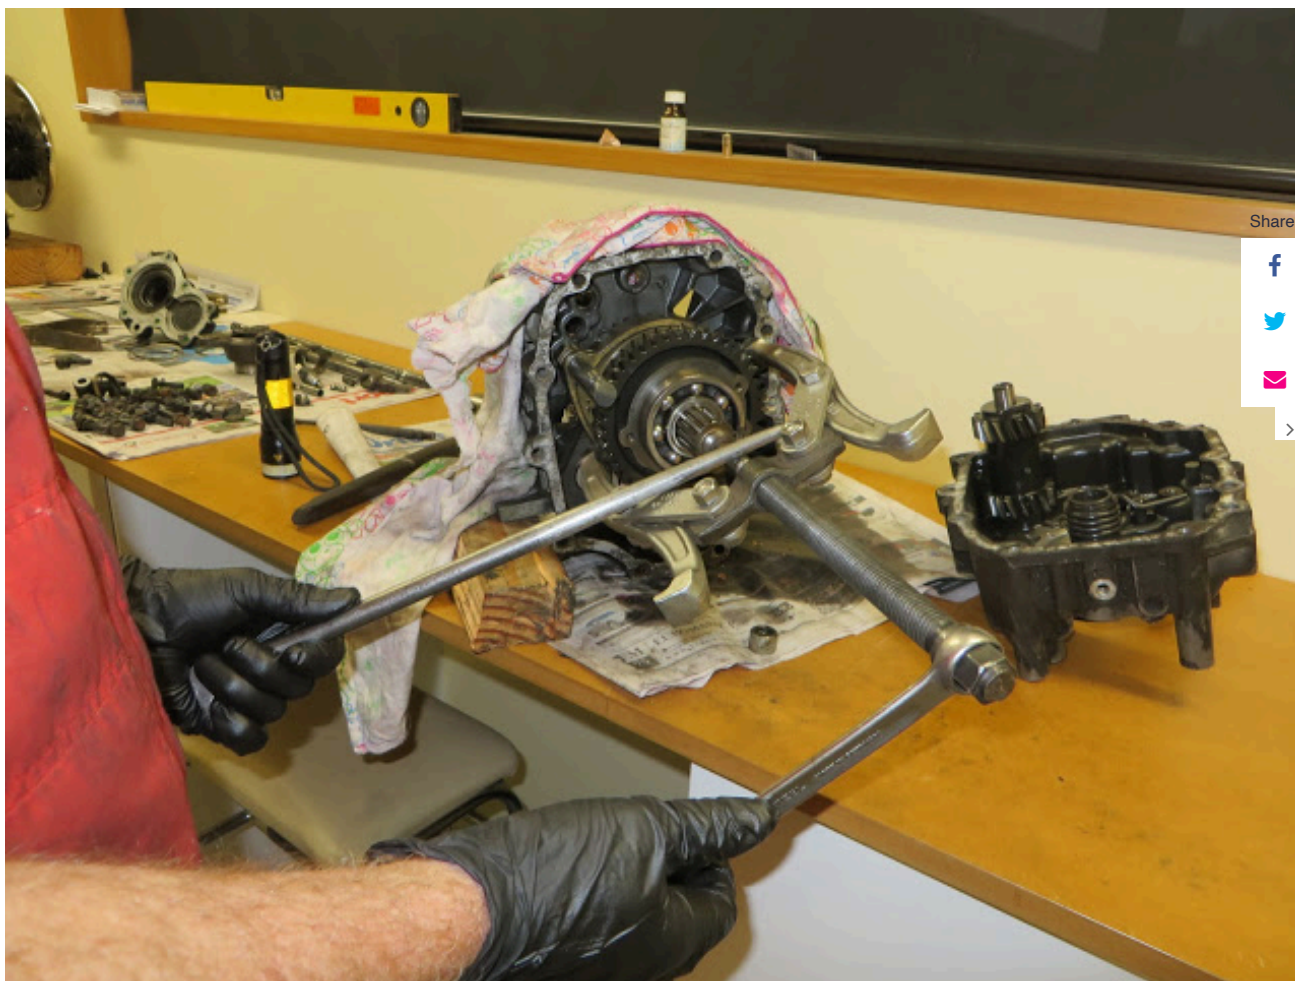
To get the reverse gear and main output shaft bearing off a puller is required along with some heat from a hot air gun.

Removed reverse gear with this puller, one thing common in this box everything is a really tight press fit and makes disassembly a bit nerve racking.

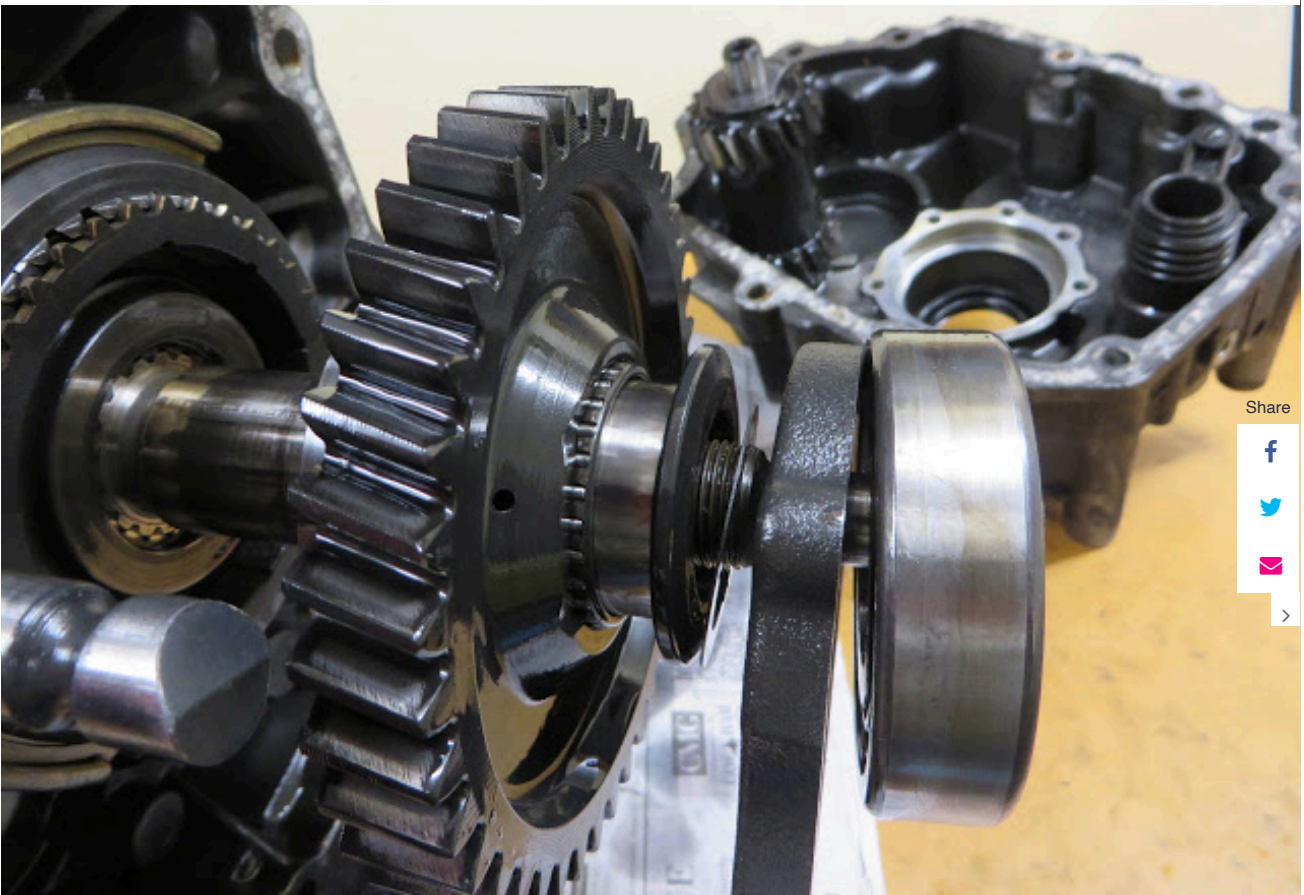
All parts loose making note of what shim goes where. The two c rings holding the synchro hub on not showed in photo.

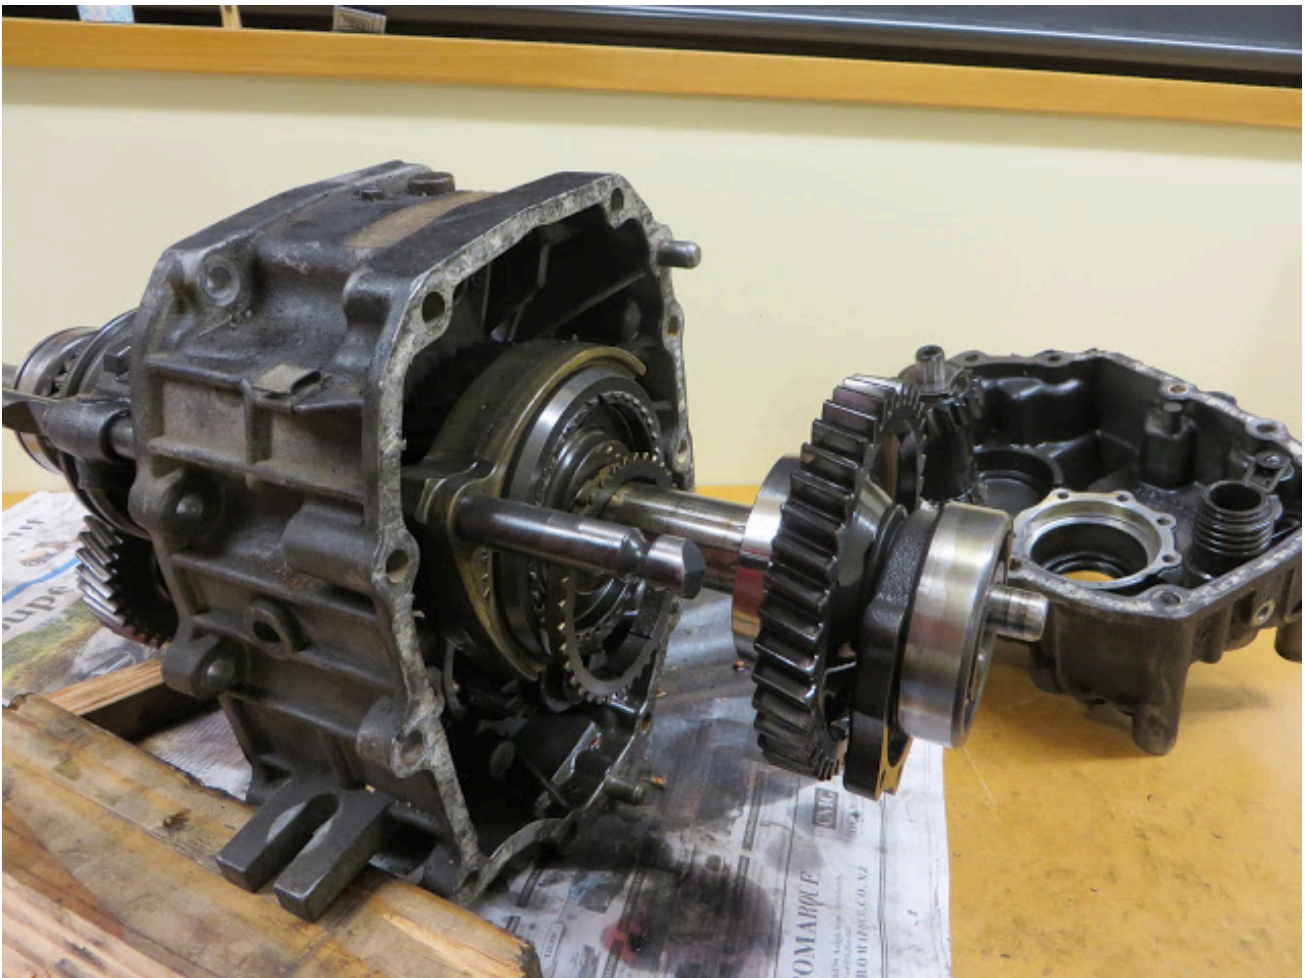
Reverse gear loose and 1st reverse synchro hub which has to be removed as an assembly along with the shift rod by sliding it out along the out put shaft.

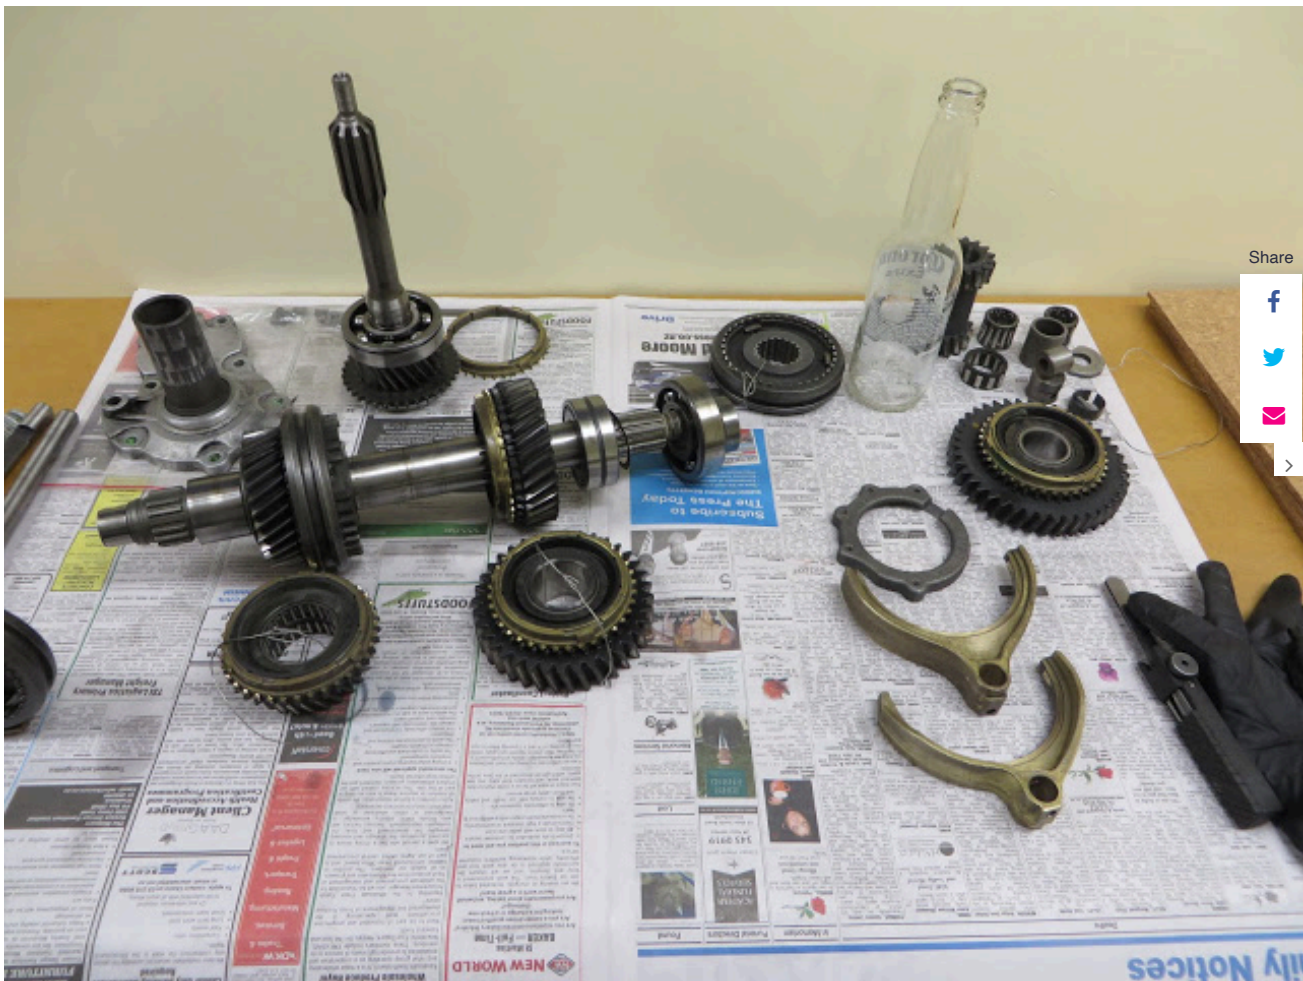
The input shaft housing had a lot of corrosion staining on it and tried various cleaners to scrub it with including cleaning in an Ultra sonic cleaner bath.

What worked best for general cleaning was scrubbing it with brass pot scrub pad but this made areas extra shinny which is not what I was trying to achieve.

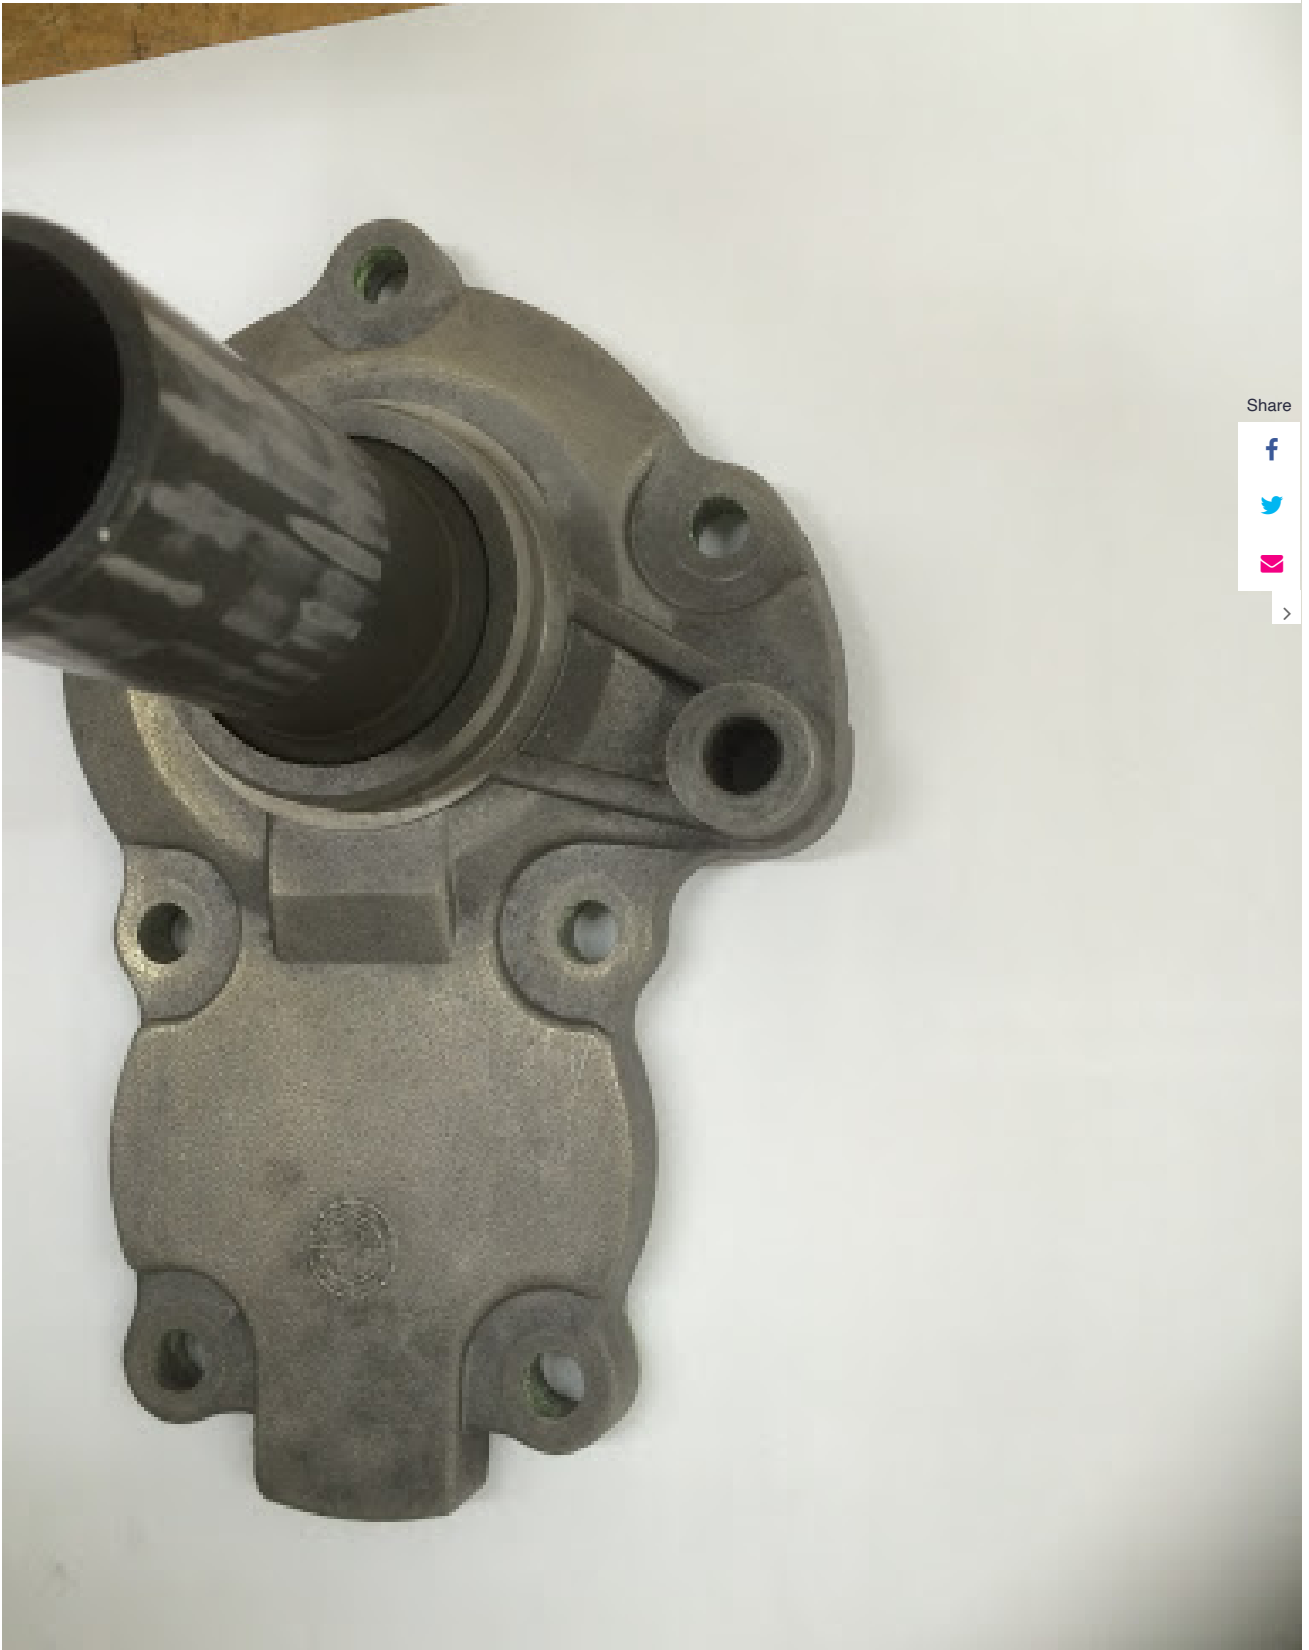
After researching on the computer I tried soaking it in hot water with clothes wash powder.

This had the affect of lightly eating at the surface by being slightly acidic.

To counter this through clean in straight hot water and finally coated in alodine this forms a protective layer to stop any future corrosion from dampness.
