## GETRAG 265/5 REBUILD

Article by: **Dave @NZ**

Article applies to: all BMW models with the Getrag 265/5 transmission.

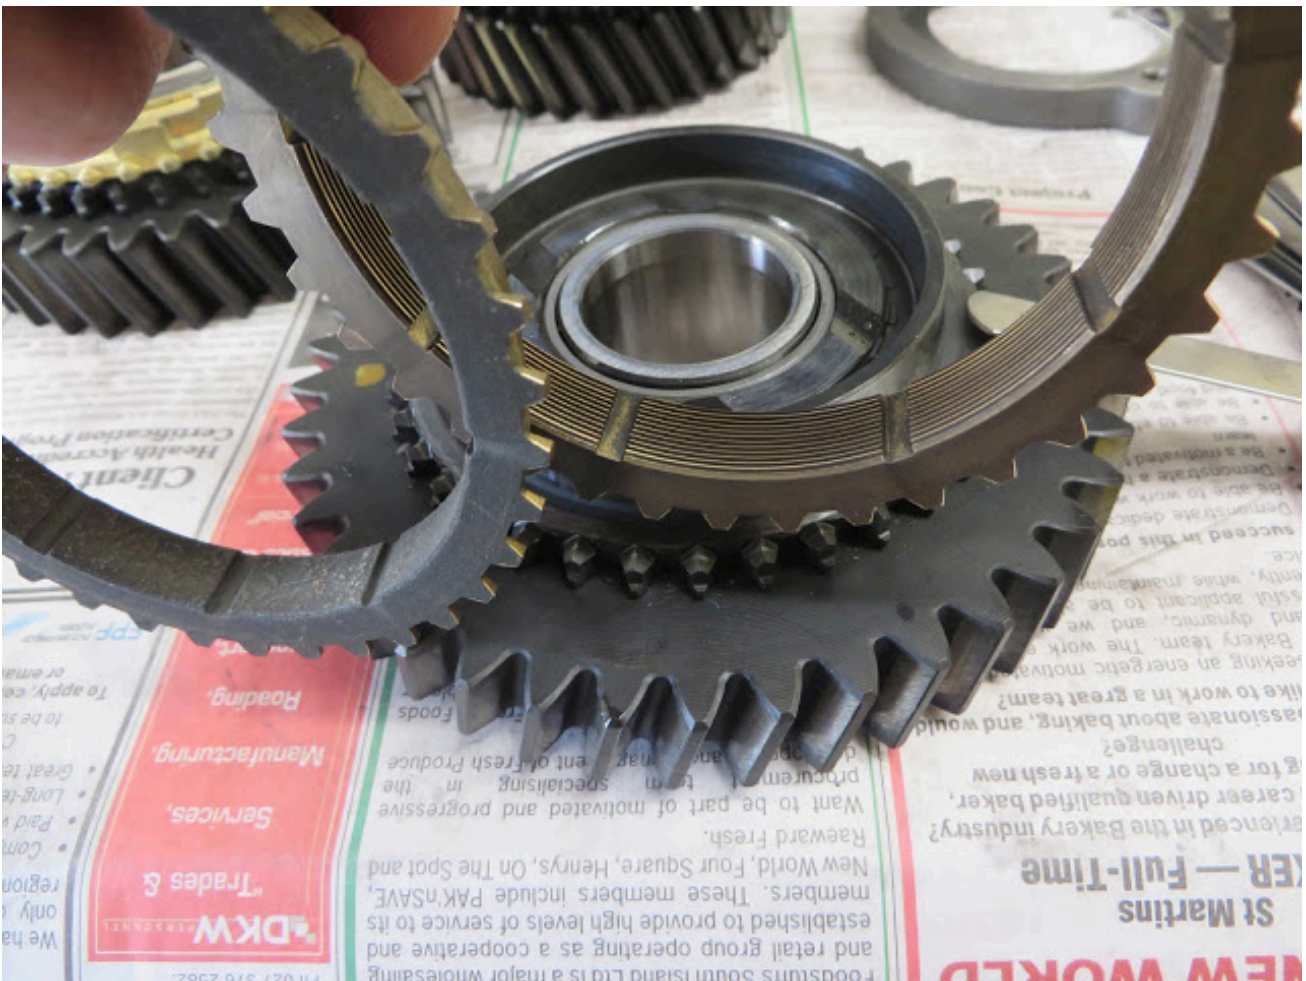
Next up is the synchro rings for a measure up, reverse on the left fwd synchro rings on the right.

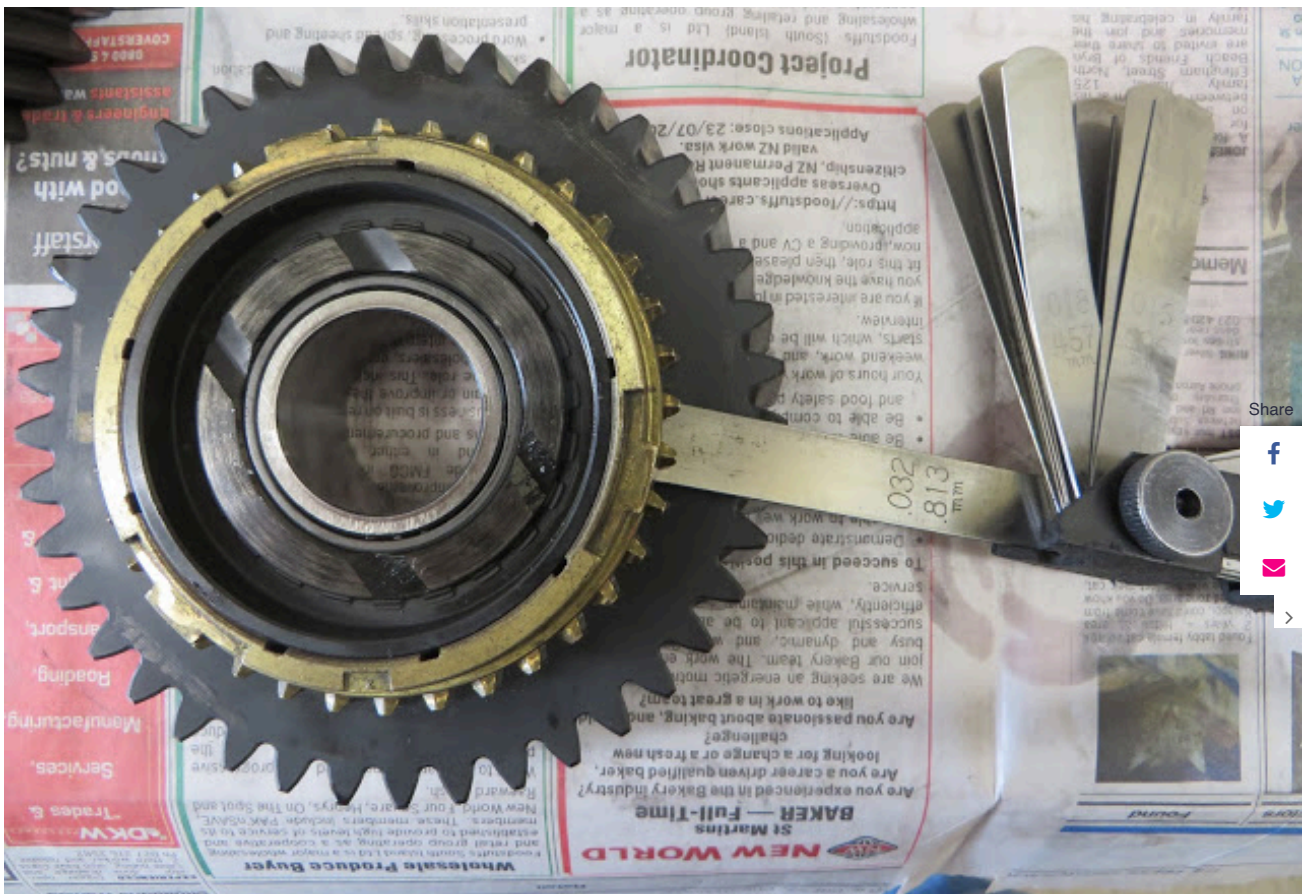
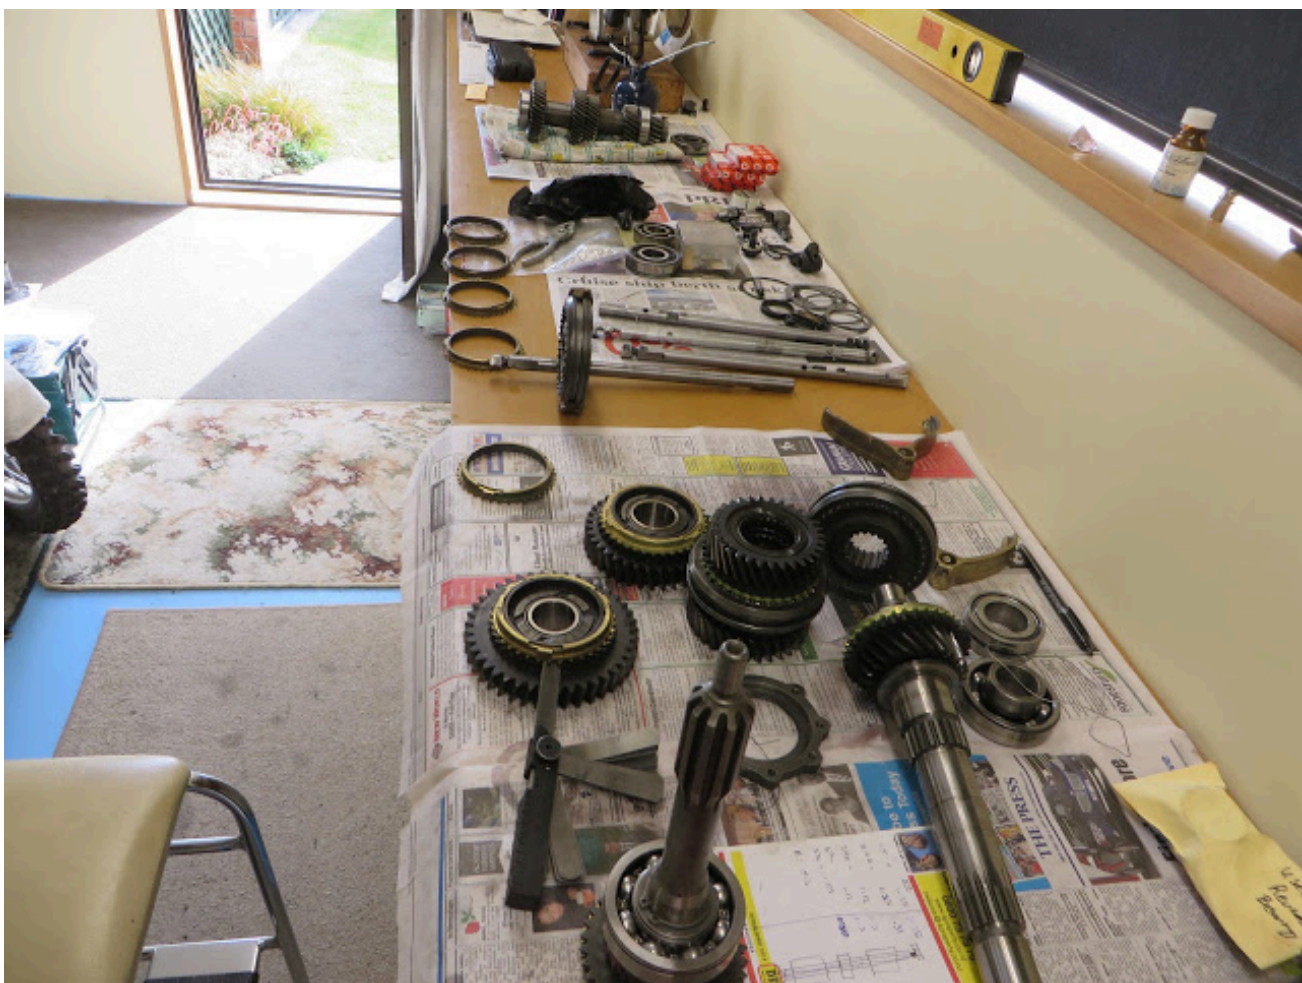
This is where things get interesting the wear from 160K od KMs is quite minimal and all fwd syncros with in spec with reverse borderline.

Gear	Thickness	Thickness
3rd	1.12mm	1.30mm
4th	1.12mm	1.30mm
5th	1.05mm	1.25mm
Reverse	0.04mm	0.08mm

Reverse gear, 0.5-0.6 new less than 0.4mm replace.

Forward syncros 1.0 to 1.3mm.

I used new oem syncs supplied by Pelican Parts they looked identical in every way to the ones removed and a lot cheaper than the BMW oem items.

For reverse I used the best used forward synchro and installed it in the new position reverse no worries.

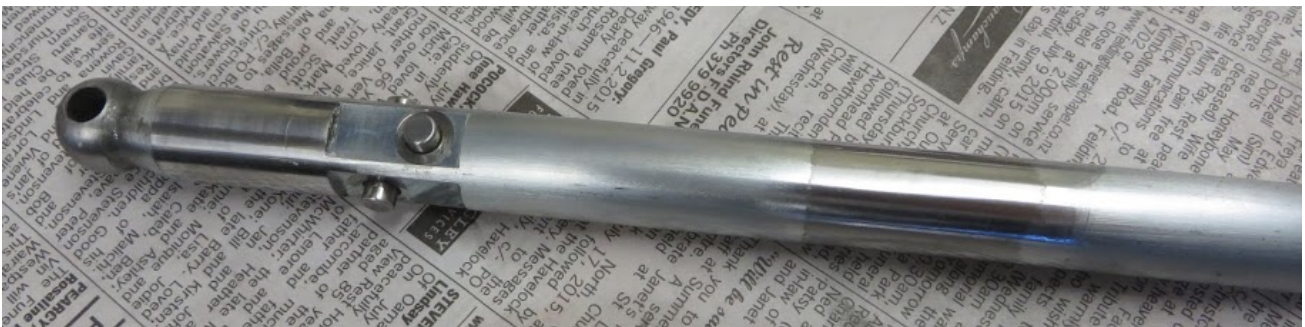
The shift rod 2nd from the left is the input shaft and you can notice the rings around it.

This is where the seal has been sitting a close look reveals the shaft is coated in in what looks like zinc to stop corrosion only problem is it has a rough edge where the seal has worn through it.

What I did was polish the seal area and all the shift rods where they go through bushes just to help smooth gear shifting and prolong the seal life.

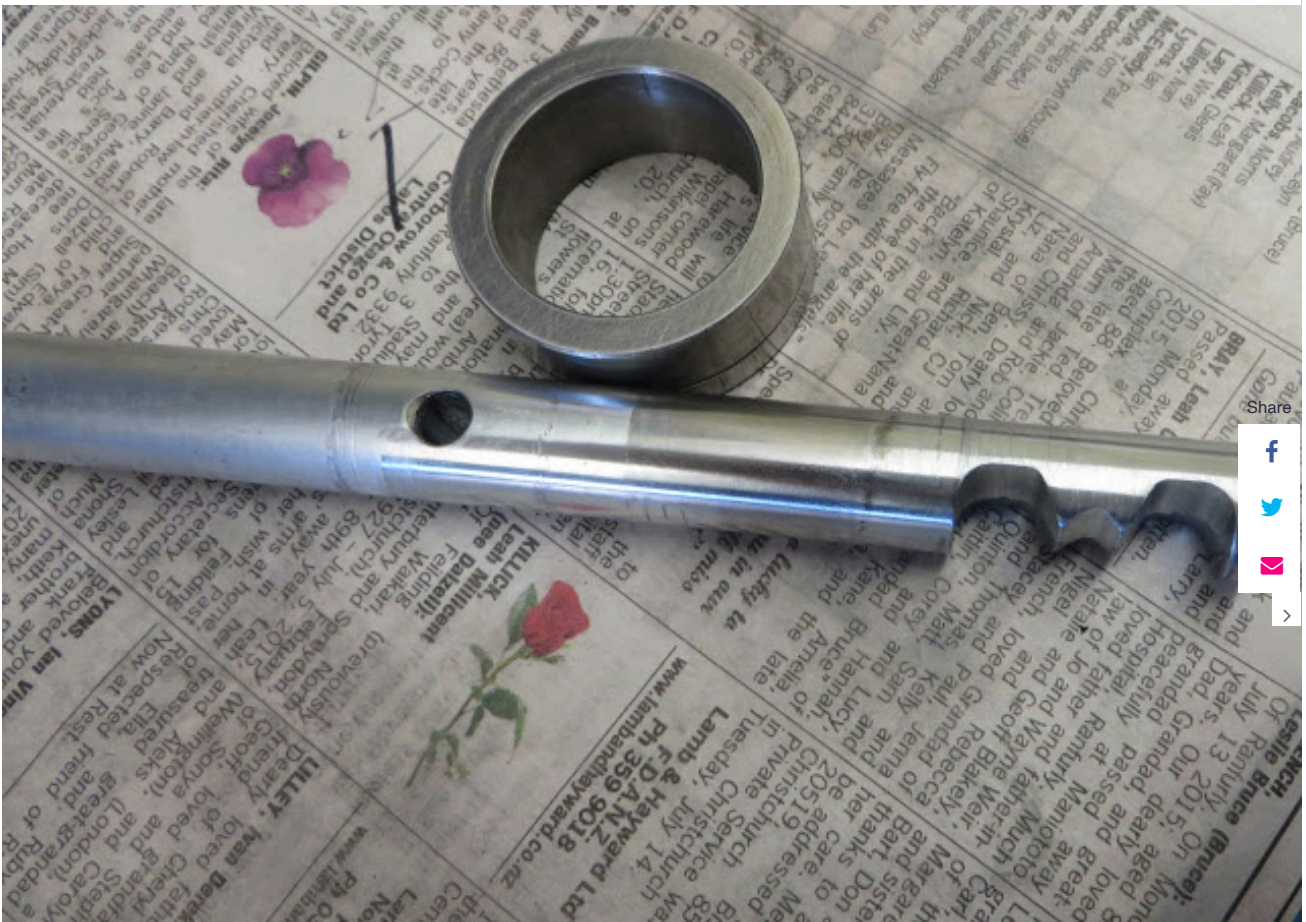
This is the single most expensive part I brought for the gearbox enough to make your eyes water.

It is the main shaft roller assembly inner sleeve and outer race.
